SAVE OUR SHEETS! AVOID 'HYDROBURSTS'

Water trapped in high thread-counts sheets can damage textiles during extraction; we look at causes and prevention

By Sam Garofalo

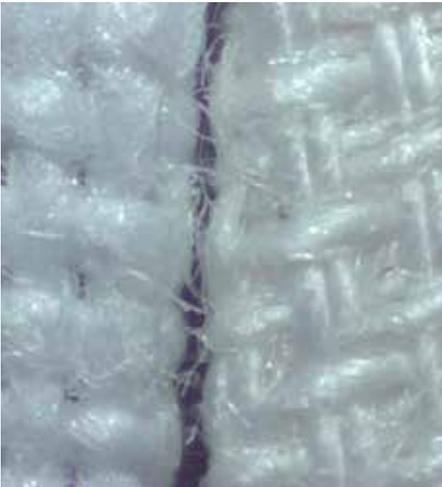
T-250-plus, 60% cotton 40% polyester sheet is excellent because the polyester is stronger more durable and supports the cotton. The photo (figure 1) shows a side-by-side comparison of a T-180 sheeting sample on the left and a T-300 on the right.

As you can see, the T-180 has space in between the yarns where water can escape. The yarn diameter also is visible.

FIGURE 1: T-180 (left) has more room for water to escape than T-300 (right).

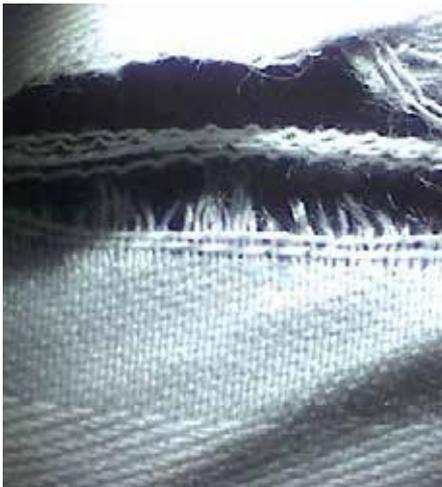
FIGURE 2: Created hydroburst

I've created a hydroburst by taking a sheet and placing a latex surgical glove

filled with water, tying it off and tightly tie-wrapping it in the fabric. The sheet then was thrown into the press can on top of the load just before the ram came down.

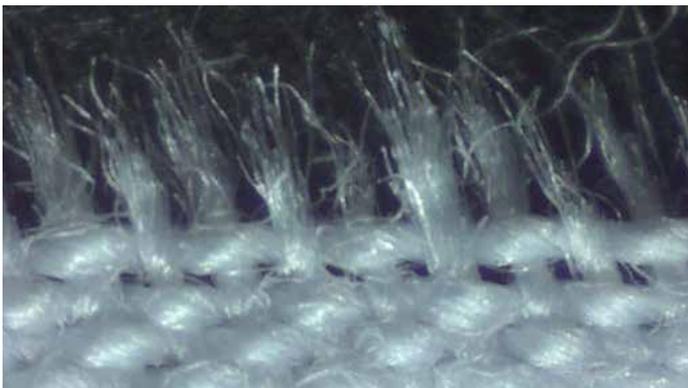
a microscope, the condition of the torn yarn ends will go a long way in identifying a new burst from old damage. In my opinion, most hydroburst damage has some root fabric issues either in the manufacturing, type, age or normal chemical degradation from continuous washing processes.

FIGURE 3: Created hydroburst at higher magnification. Note yarn ends

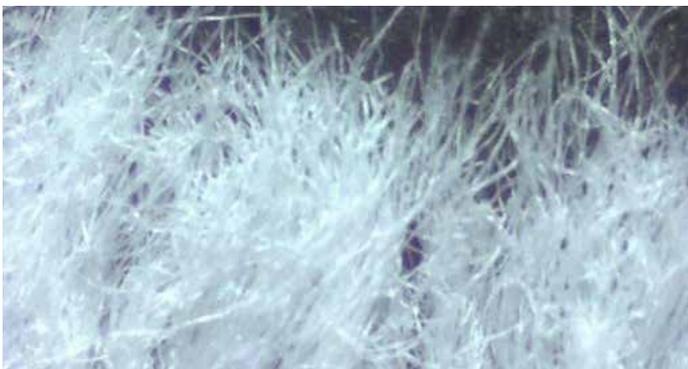
FIGURE 4: Compare yarns ends from a sheet that had been washed several times after original damage above.

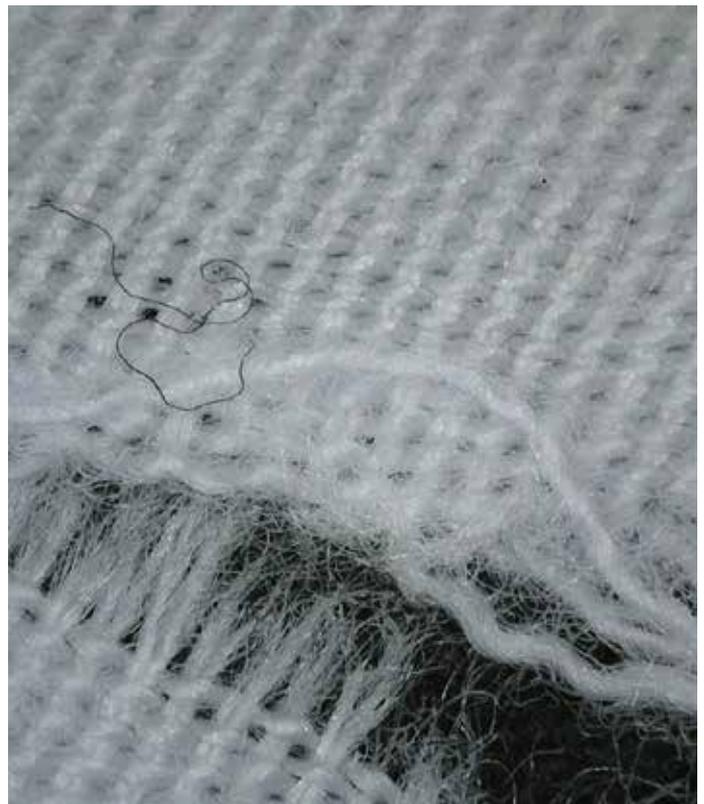
If you find a hydroburst where the fibers in the tear look fresh as seen in the photo below, this is the sample you send to the lab. A new hydroburst will have identifying features, or "fingerprints" not seen in manufacturing, equipment and the other issues. The picture at left shows where water trying to escape the tight weave pushed the yarns apart before the larger burst below was created. This photo is perfect example of a hydroburst.

FIGURE 5: The image above shows how water seeking to escape the tight weave pushed the yarns apart before creating the hydroburst shown below.
