Rust Never Sleeps

Control chlorine use to safeguard tunnel washers

Rust Never Sleeps: Part II

Field-tested techniques aimed at reducing the threat of corrosion in today's batch tunnel washers

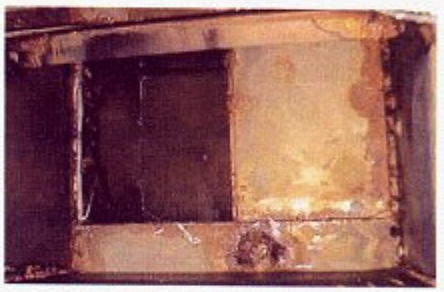
Photo #2 This tunnel had significant face plate and clean end cylinder rust damage. Ironically, a new tunnel of the same manufacture was installed right next to the old one. At the time of the installation of the new tunnel, the chemical company switched from a fluoride-based sour to a phosphoric-based sour. After several years of operation, the new tunnel, which utilized phosphoric sour, had no corrosion. The older tunnel that had previously used fluoride-based sour exhibited no increase in corrosion. In some cases, we have seen a reduction in the corrosion process when the change to phosphoric acid was made. Note: the corrosion seen on this tunnel should be cleaned, and the metal should be repassivated.
